# Manhole Inspection Summary

Manhole # S2100\_008MH

**Location** Address: **2856 WOODBROOK AVE**

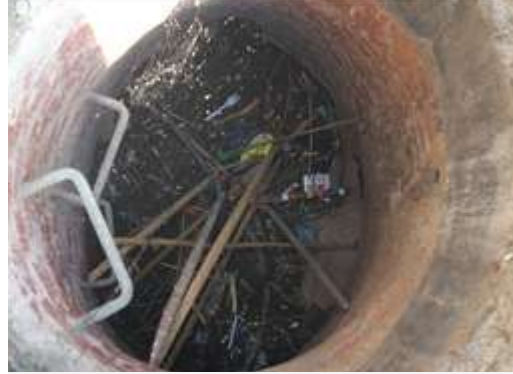
Top View

Debris on channel

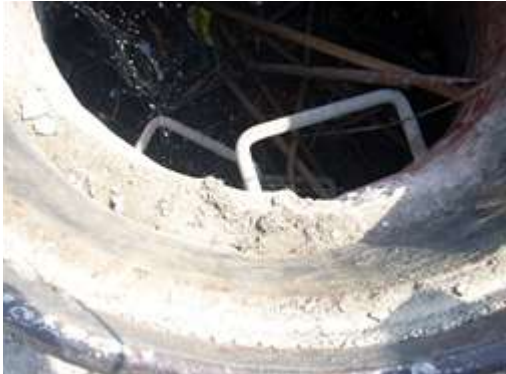
Defect 1

Offset: **3** (in.)

FRAME OFFSET

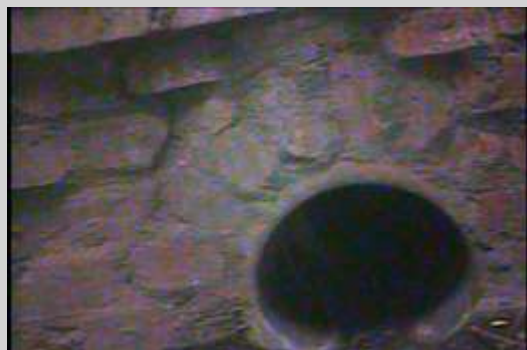
12 O'Clock Outflow

8 in. Circular Gravity Sewer  
Pipe Out @ 12 O'Clock

Deposits: ☐ None ☐ Mud ☐ Sludge ☒ **Debris** ☐ Grease

Silt Depth: **1** (in.) Deposits Extent: **Light**
